# Heritage Tree Removal Permit Application

Application No. 2010-058

Re: Preliminary Geotechnical Evaluation  
Existing Apartment Building  
946 Florence Lane  
Menlo Park, California

**Subject: Application to Remove Heritage Trees at 946 Florence Lane**

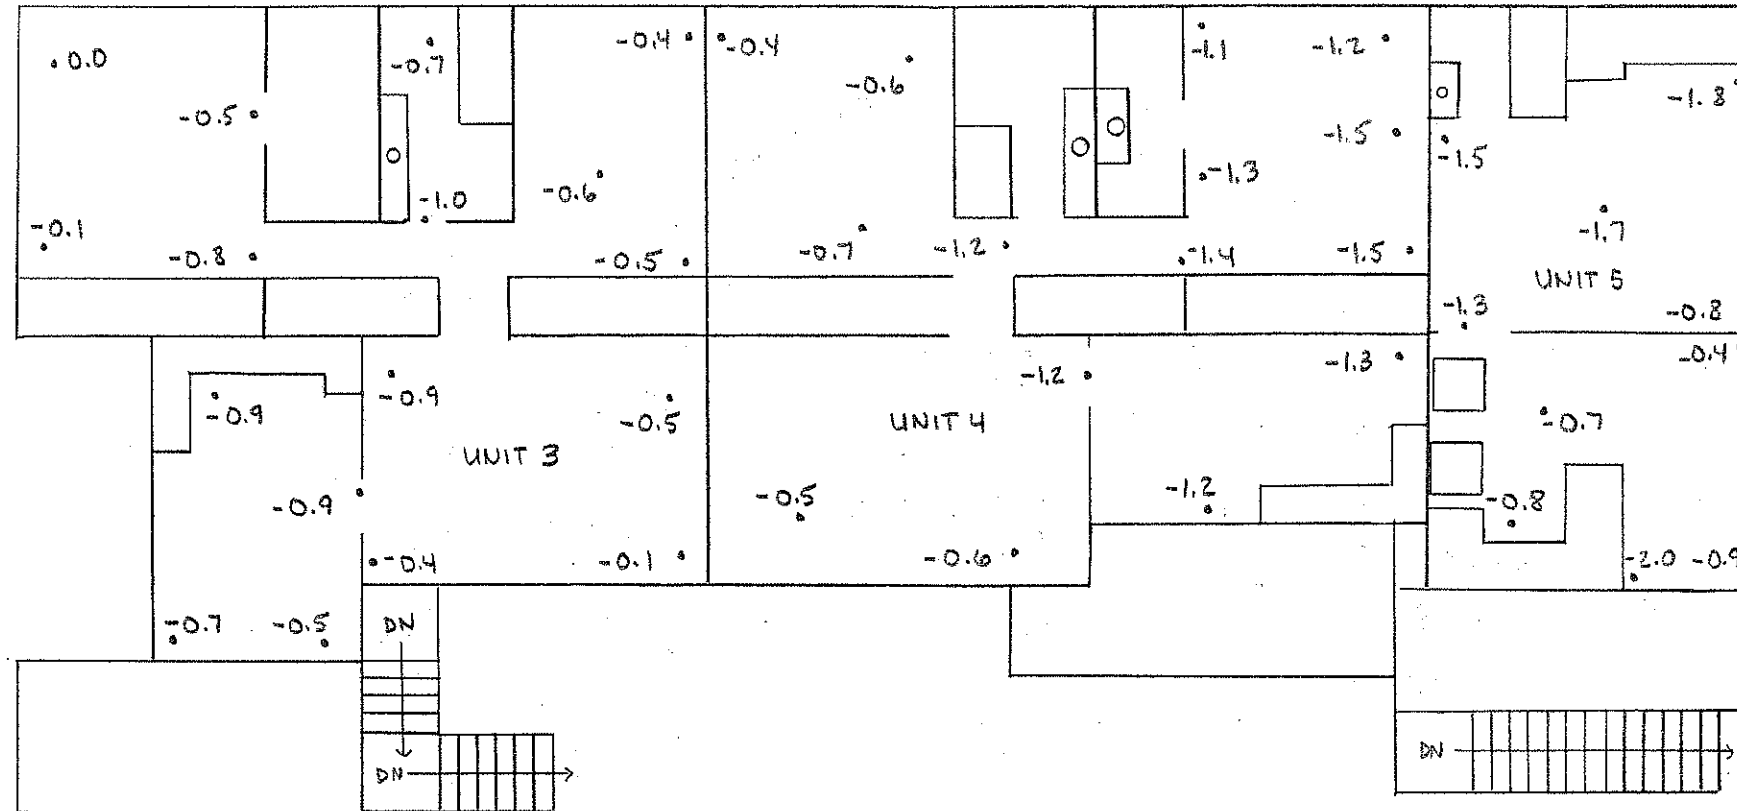
Figure 1

From a geotechnical viewpoint, the building appeared to be in reasonably good condition. We did observe several areas in the interior walls where cracking had occurred, especially within the walls and ceilings of units 2 and 4 (4 being the upper middle unit). In order to evaluate the performance of the building foundation, we measured the floor plans of the upper three units (Units 3, 4 and 5) and conducted a relative floor elevation survey on the upper floor using a water-filled manometer. The result of the survey, included on the attached Figure 1, suggest that the structure is about 2 inches out-of-level. It is noted that the measured "low point" corresponds to an area above the front left hand carport. Since no footing underlies this location, the "low point" is in an area where the floors have sagged over the open space.

**Relative Floor Elevation Survey  
Upper Floor Units (Units 3, 4 & 5)**

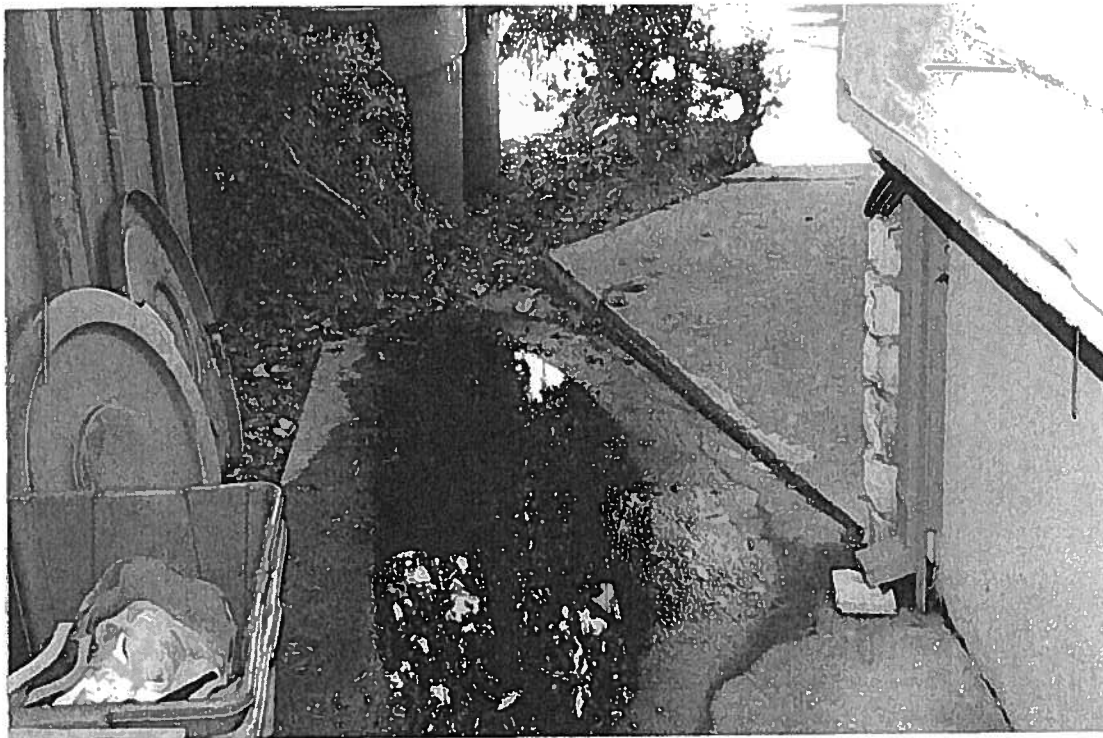
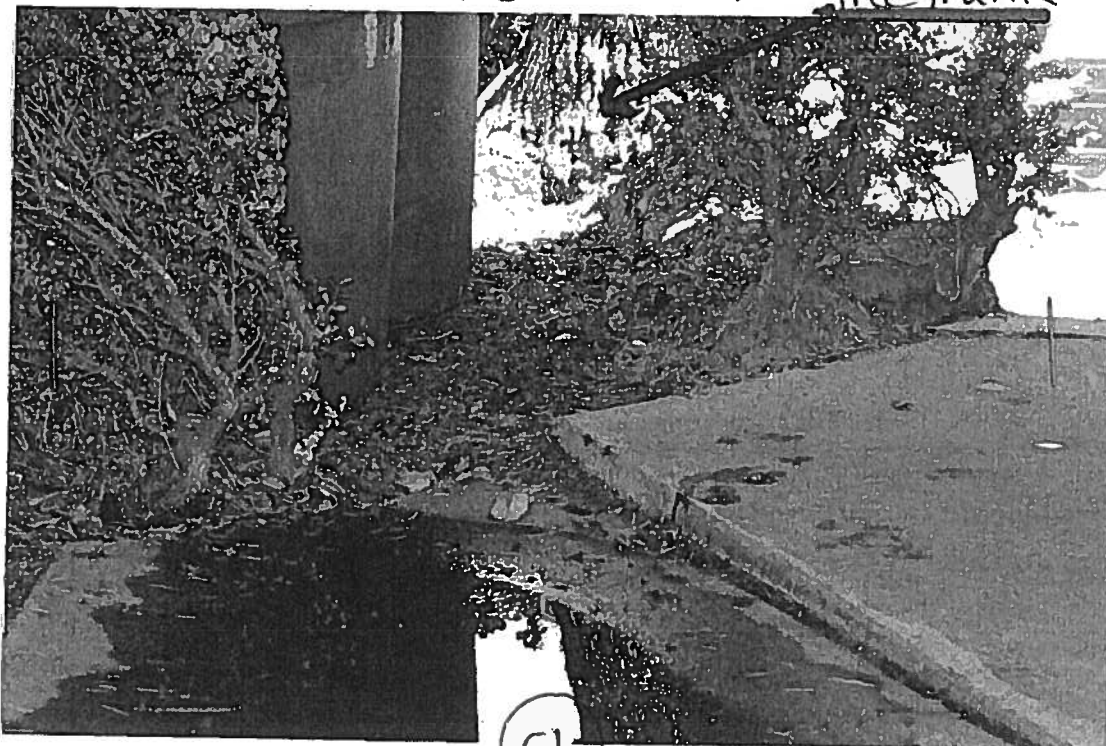
These photos demonstrates the problem with water draining away from structure, water flows back under the structure rather than out to the street. Tree-trunk

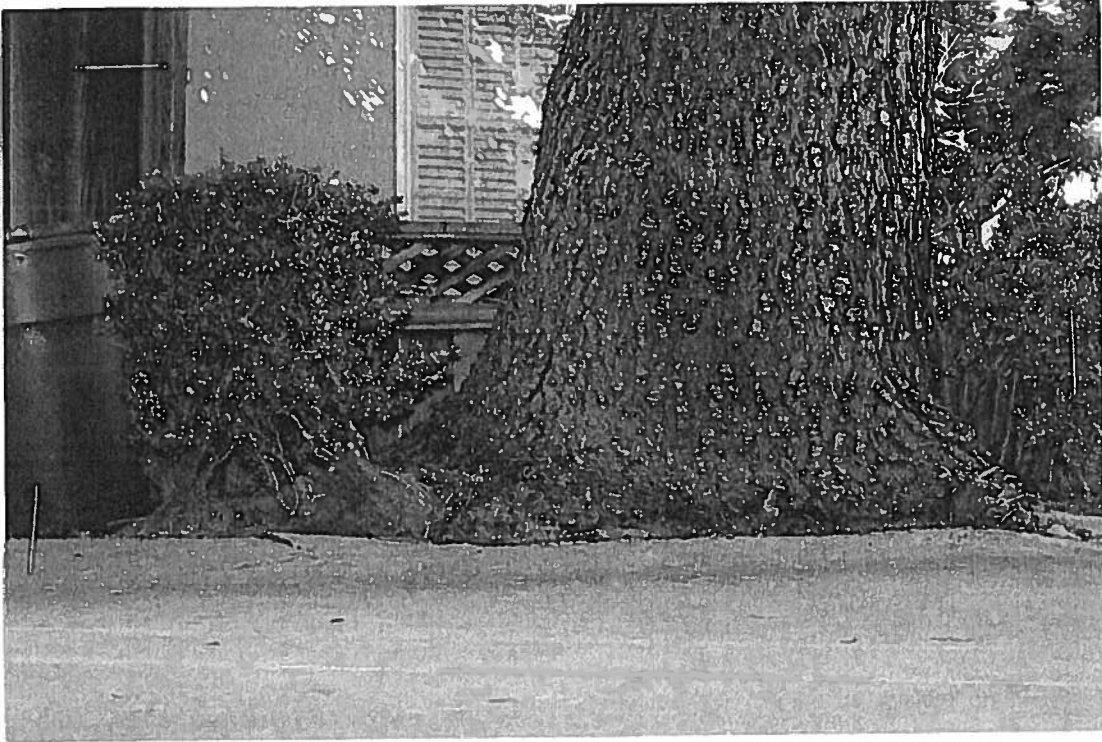
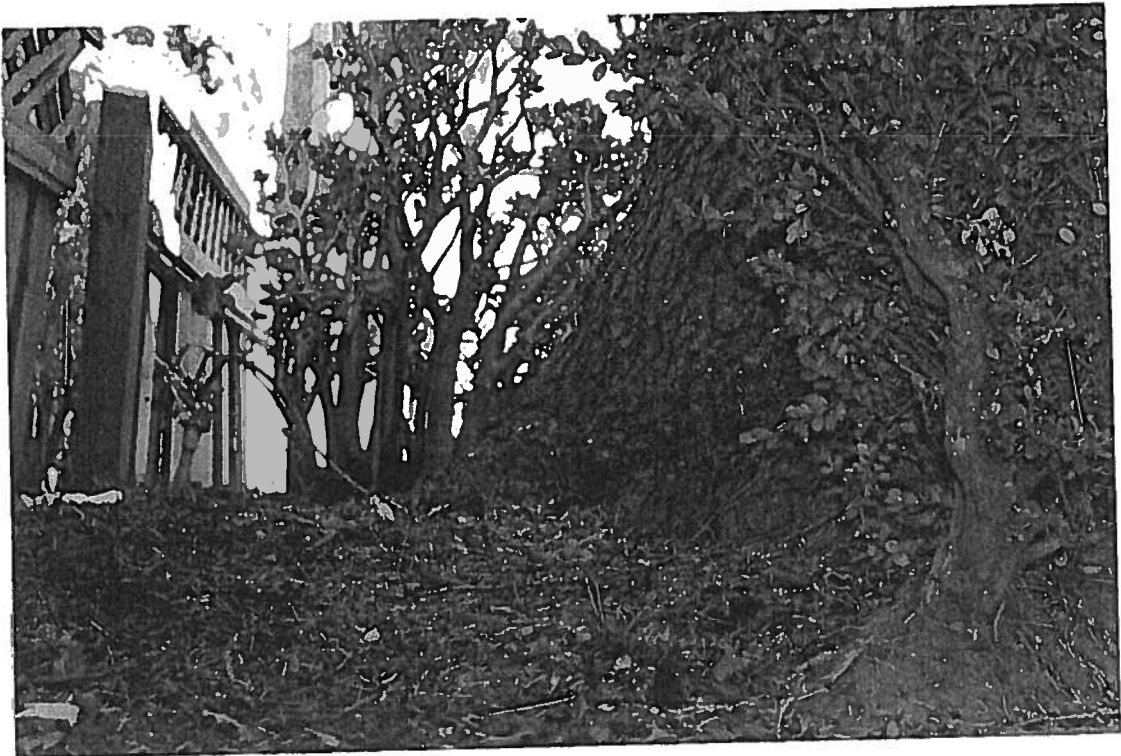
These pictures demonstrates the roots causing a large knoll and the tree is tipping over. The roots are creating problems with drainage, and sewer lines.

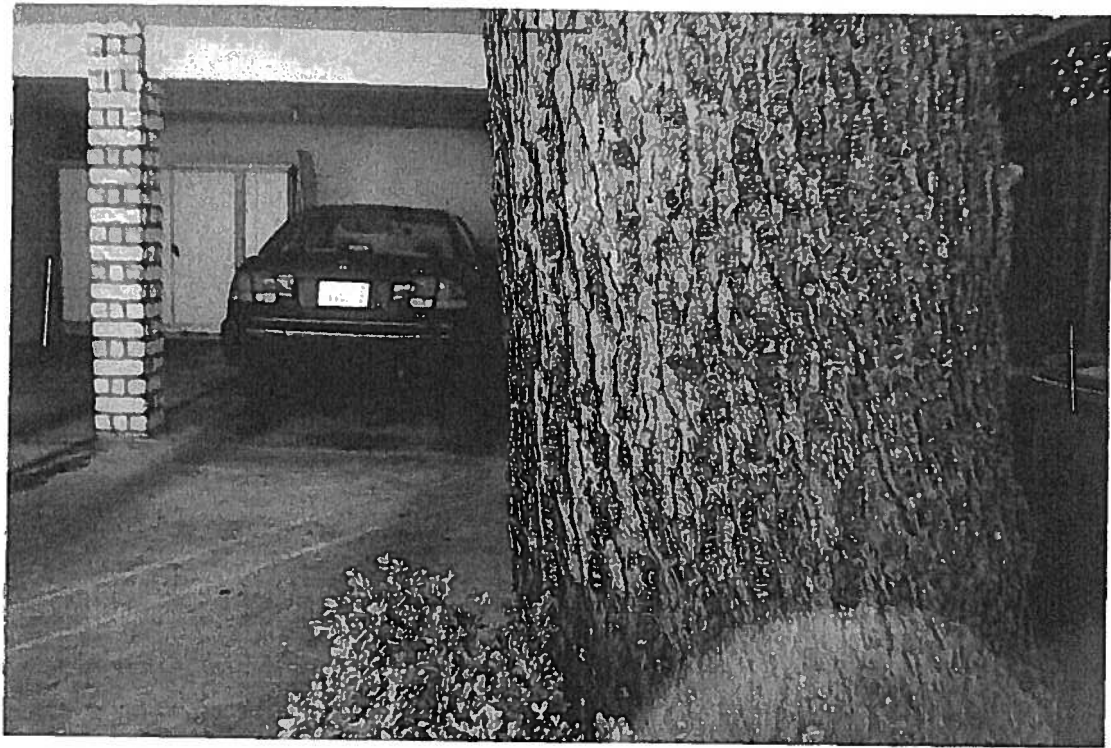
This top photo demonstrates the tree is beginning to grow into the driveway.

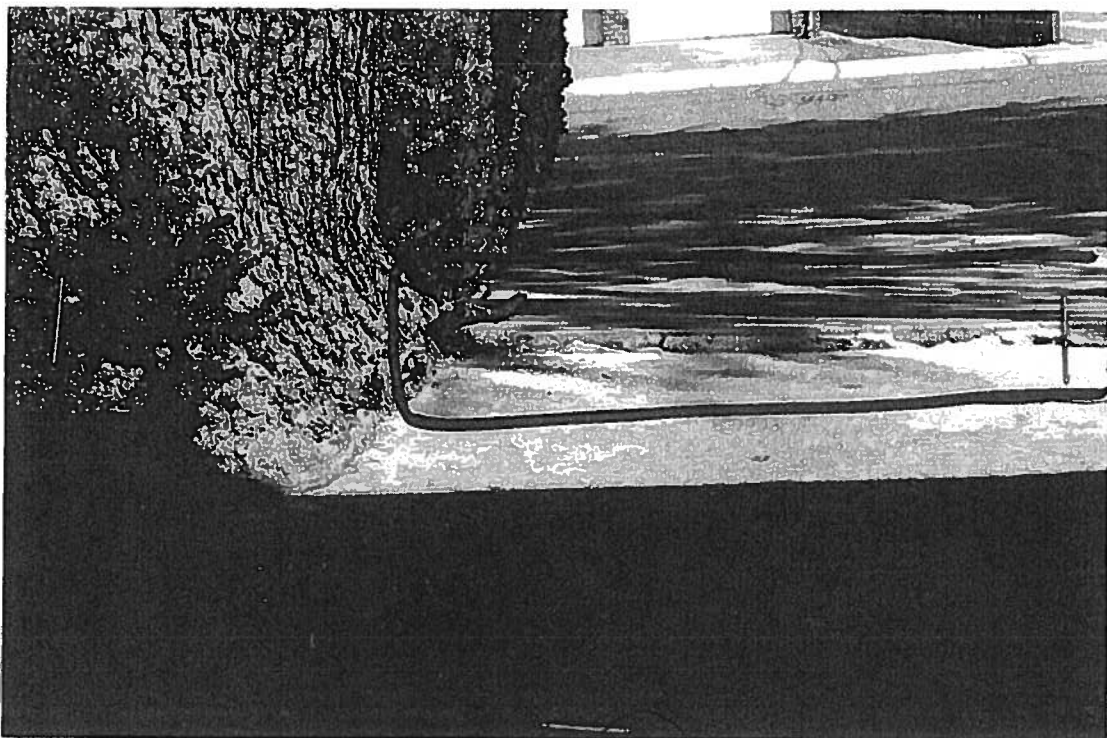
This lower photo demonstrates where the roots have lifted the driveway.

Concrete Lifting
