**BANK STABILIZATION AND REVEGETATION RECOMMENDATIONS**  
 SAN FRANCISCO CREEK  
 BANK STABILIZATION & REVEGETATION  
 PRELIMINARY MASTER PLAN REPORT

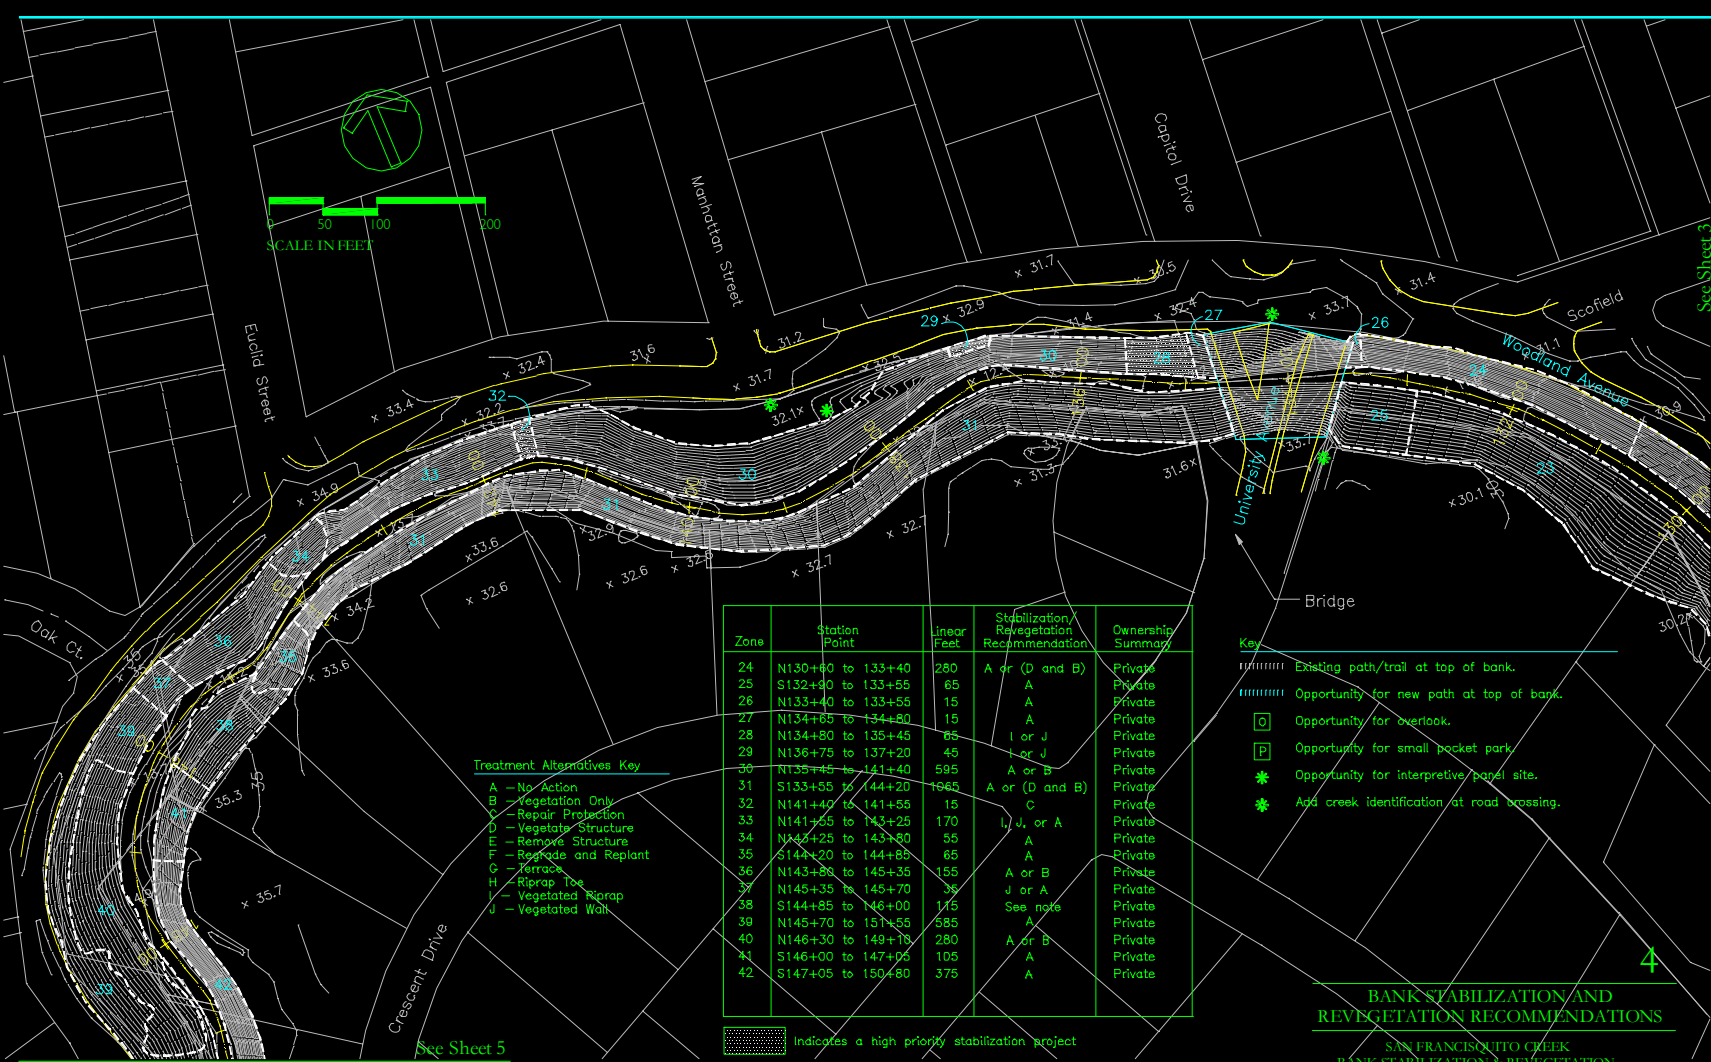
- A - No Action
- B - Vegetation Only
- C - Repair Protection
- D - Vegetative Structure
- E - Remove Structure
- F - Retain and Replant
- G - Terrace
- H - Riprap Toe
- I - Vegetated Riprap
- J - Vegetated Wall

Zone	Station Point	Linear Feet	Stabilization/Revegetation Recommendation	Ownership Summary
24	N130+00 to 133+40	280	A or (D and B)	Private
25	S132+60 to 133+55	65	A	Private
26	N133+40 to 133+55	15	A	Private
27	N134+65 to 134+80	15	A	Private
28	N134+80 to 135+45	65	I or J	Private
29	N136+75 to 137+20	45	I or J	Private
30	N135+45 to 141+40	595	A or B	Private
31	S133+55 to 144+20	1865	A or (D and B)	Private
32	N141+40 to 141+55	15	C	Private
33	N141+55 to 143+25	170	I, J, or A	Private
34	N142+25 to 143+80	55	A	Private
35	S144+20 to 144+85	65	A	Private
36	N143+85 to 145+35	155	A or B	Private
37	N145+35 to 145+70	35	J or A	Private
38	S144+85 to 146+00	115	See note	Private
39	N145+70 to 151+55	585	A	Private
40	N146+30 to 149+15	280	A or B	Private
41	S146+00 to 147+05	105	A	Private
42	S147+05 to 150+80	375	A	Private
